External Inspection and Condition Assessment Survey

Client: South Orange County Wastewater Authority
Date: January 24, 2023
Attn: Amber Baylor
Director of Environmental Compliance
Subject: Ocean Outfall External Inspection and Condition Survey of the ACOO

Client: South Orange County Wastewater Authority
Date: January 24, 2023
Attn: Amber Baylor
Director of Environmental Compliance
Subject: Ocean Outfall External Inspection and Condition Survey of the SJCOO

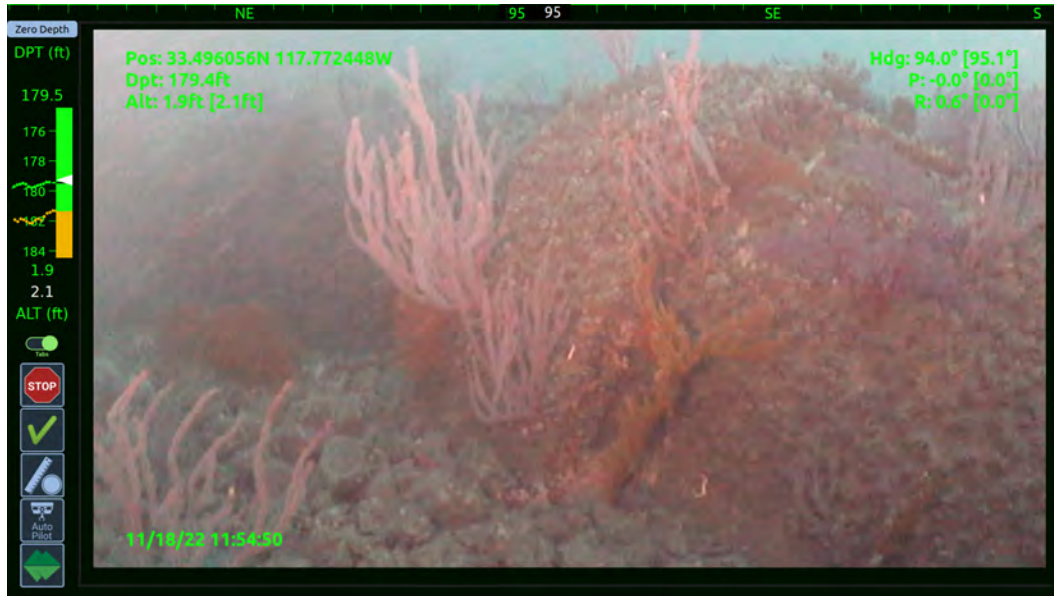
Heavy marine growth was observed covering the entire exposed external face of the ACOO. The outfall was consistently ballasted with rock at or above the springline¹ for much of the observed length. The ACOO inspection data reveals approximately 50 linear feet along the outfall where ballast was observed to be absent. The missing ballast in these isolated areas has left the outfall pipe exposed below and well below the springline. The as-built cross section of the ACOO at the diffusers is shown for reference in Figure 3.

Photo 3 - View showing the typical external condition of the ACOO

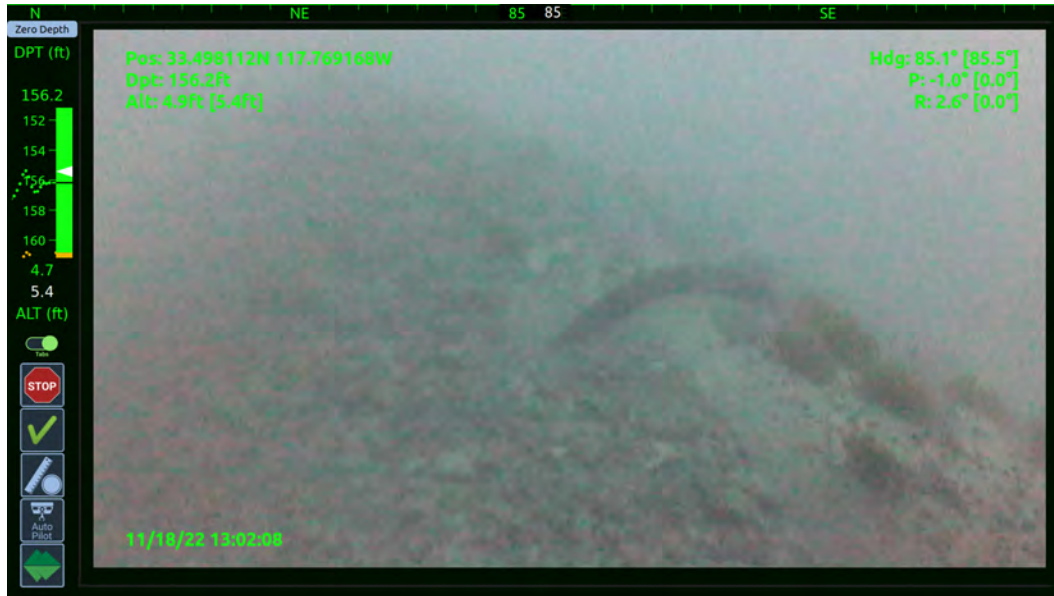
Photo 7 – View showing a section of the ACOO buried by sand

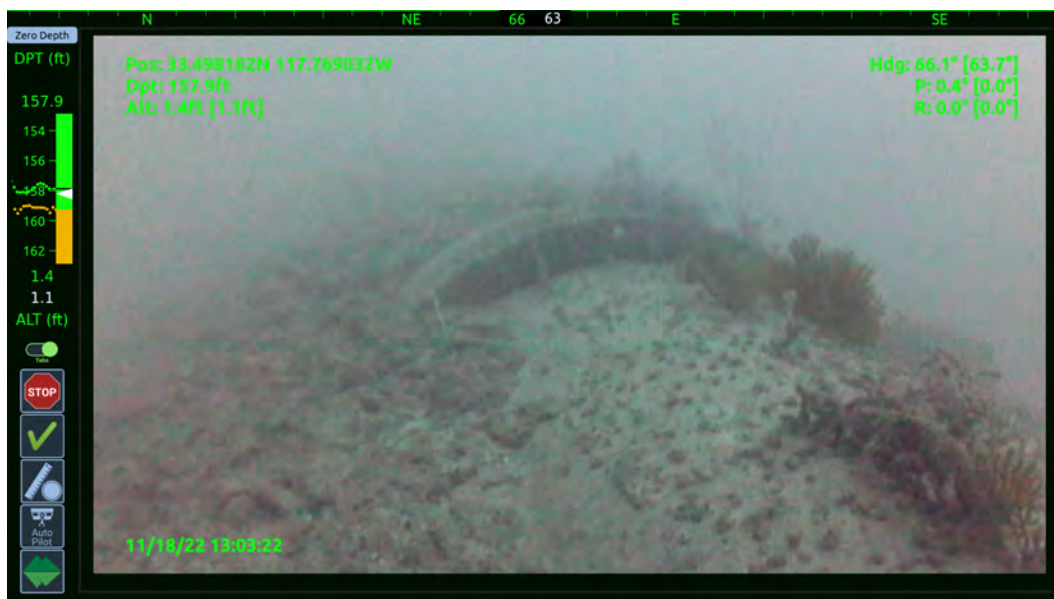
Photo 8 – Additional view showing a section of the ACOO buried by sand

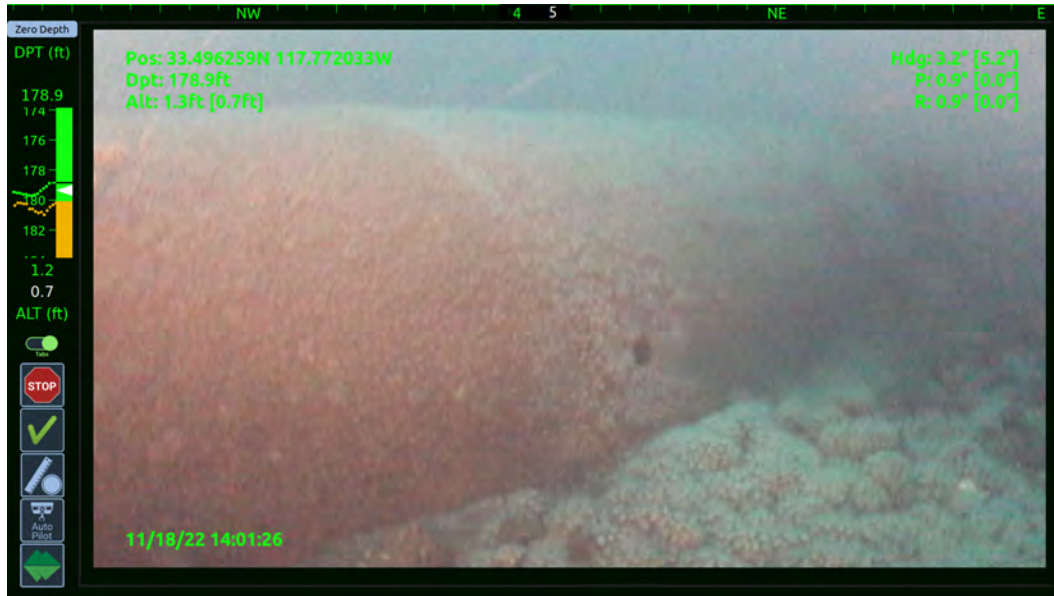
Photo 9 – View of an area along the ACOO that is missing ballast, well below the springline

1. In areas along the length of the ACOO where ballast is absent, install ballast such that the original design cross sectional is restored. The previous ballast repair efforts were observed to be in good condition. Utilizing the same means and methods would be a reasonable course of action to address the areas of missing ballast.
2. Using mechanical means and methods, clean each of the ACOO diffuser ports of marine growth and remove any obstructions.

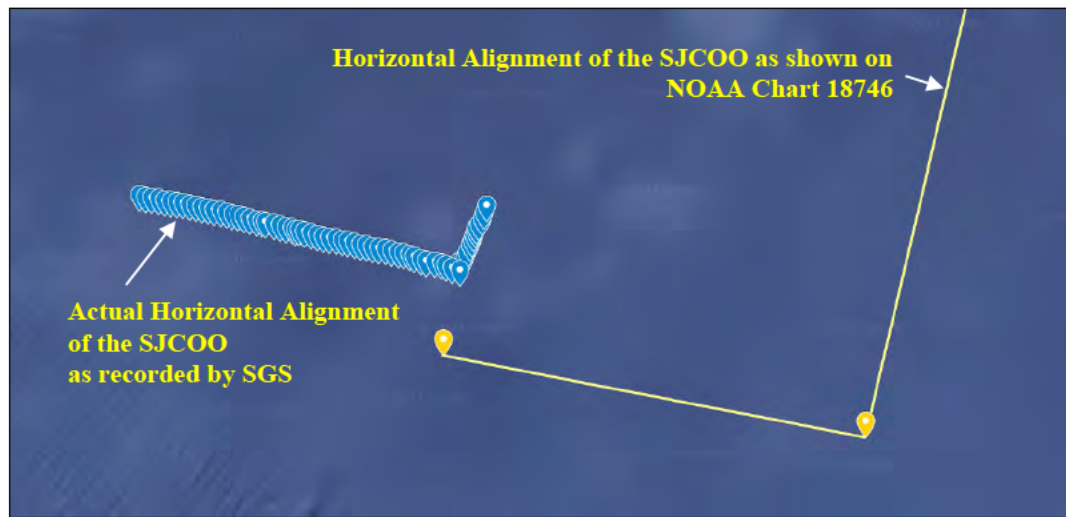
Figure 3: SJCOO Horizontal Alignment Discrepancies

This discrepancy is shown for reference in Figure 3. The discrepancy in the horizontal alignment between what is shown on the NOAA² charts (shown for reference in Figure 4) and what is present onsite amounts to approximately 1,700 feet. We have provided for reference a link to an interactive map, showing this information in greater detail³.

2. Using mechanical means and methods, clean each of the SJCOO diffuser ports of marine growth and remove any obstructions.
3. Coordinate with NOAA to update their marine navigation charts to accurately show the location of the SJCOO outfall. The horizontal alignment of the SJCOO is shown incorrectly on the publicly available NOAA marine charts. Mariners rely on these charts when setting anchors, and without the SJCOO shown correctly, it is possible that a mariner might accidentally drop anchor and damage the outfall.

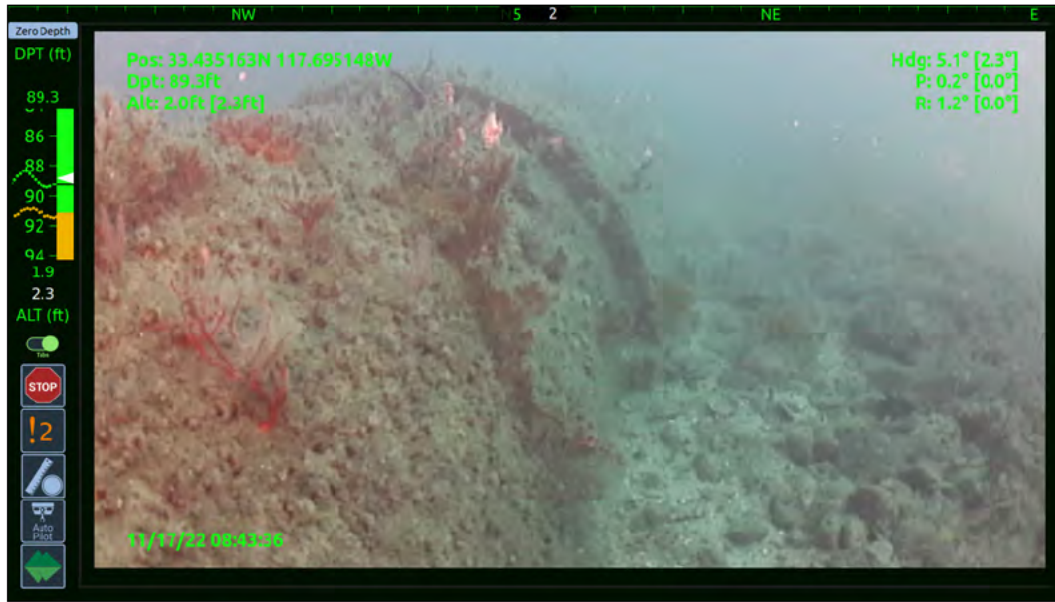
Heavy marine growth was observed covering the entire exposed external face of the SJCOO. The outfall was consistently ballasted with rock at or above the springline¹ for much of the observed length. The SJCOO inspection data reveals approximately 20 linear feet along the outfall where ballast was observed to be absent. The missing ballast in these isolated areas has left the outfall pipe exposed below and well below the springline. The as-built cross section of the SJCOO at the diffusers is shown for reference in Figure 2.

Photo 3 - View showing the typical external condition of the SJCOO

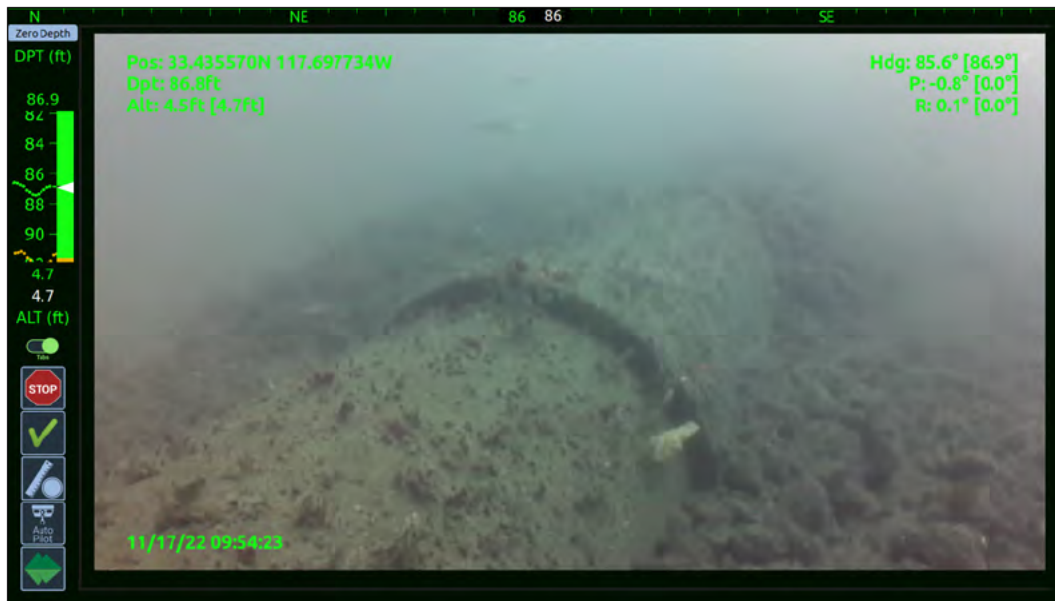
Additionally, there were several areas where the ballast completely covered the top of the outfall. In these areas, the ballast had been covered by sand, and view of the outfall was obscured. The SJCOO inspection data reveals approximately 30 linear feet where ballast is covering the outfall. This area extends from MB 16 to MB 18. Although the diffusers and the ocean outfall are covered, effluent was seen seeping up through the ballast and sand.

Photo 4 – View showing ballasting covering the top of the SJCOO

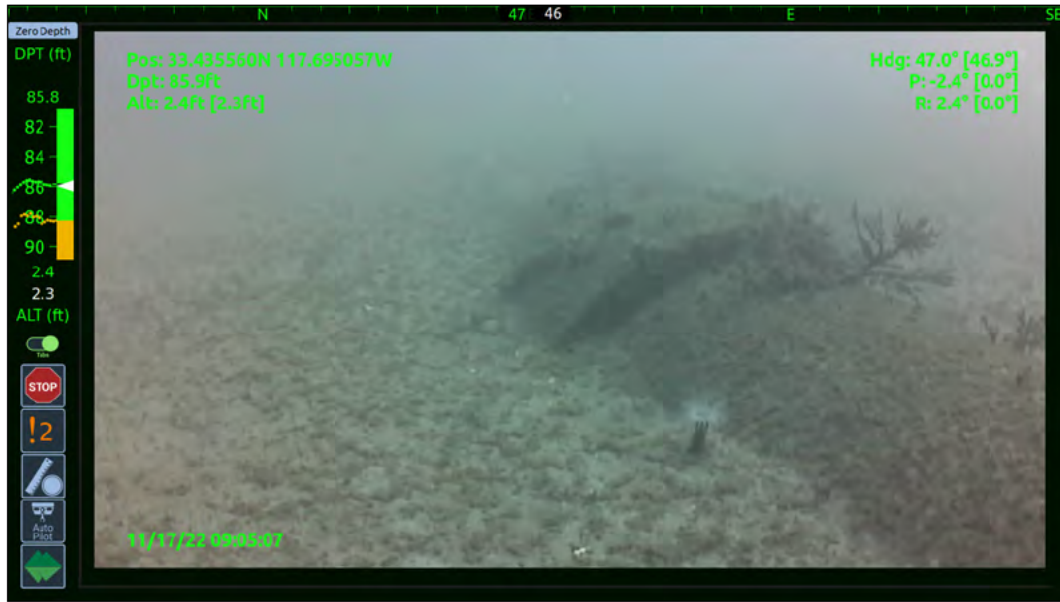
Photo 7 – View showing a section of the SJCOO buried by sand

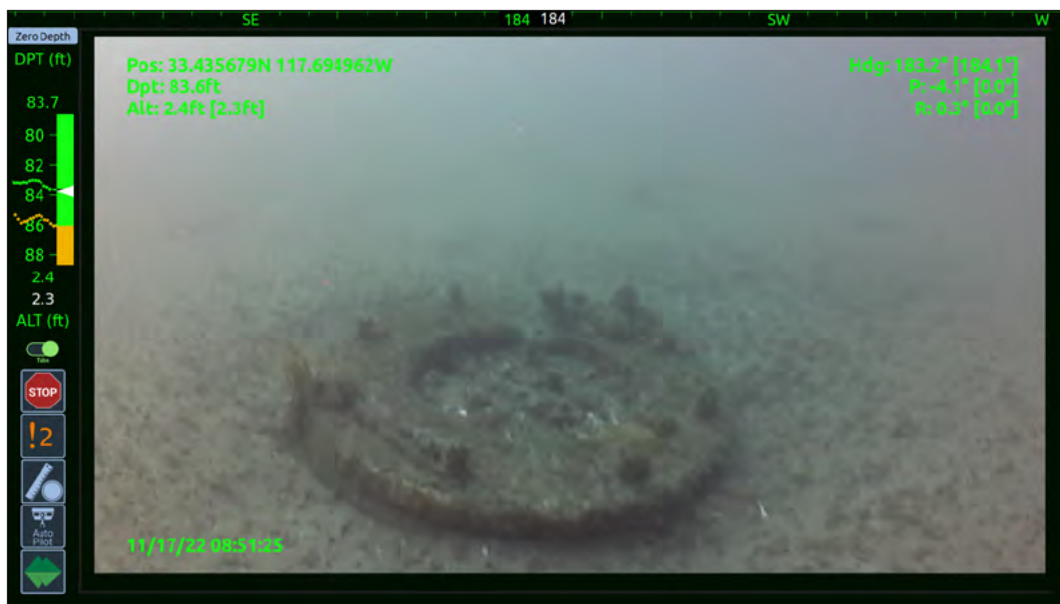
Photo 8 – View of an SJCOO outfall manhole, slightly protruding from beneath the sand

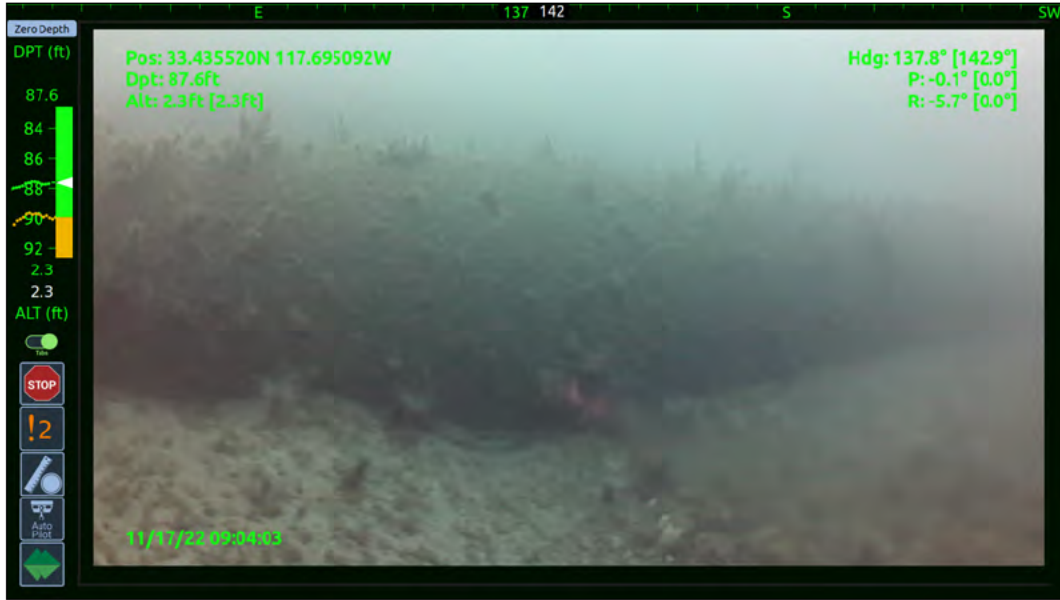
Photo 9 – View of an area along the SJCOO that is missing ballast below the springline

1. In areas along the length of the SJCOO where ballast is absent, install ballast such that the original design cross sectional is restored. The previous ballast repair efforts remain intact. Utilizing the same means and methods would be a reasonable course of action to address the areas of missing ballast.

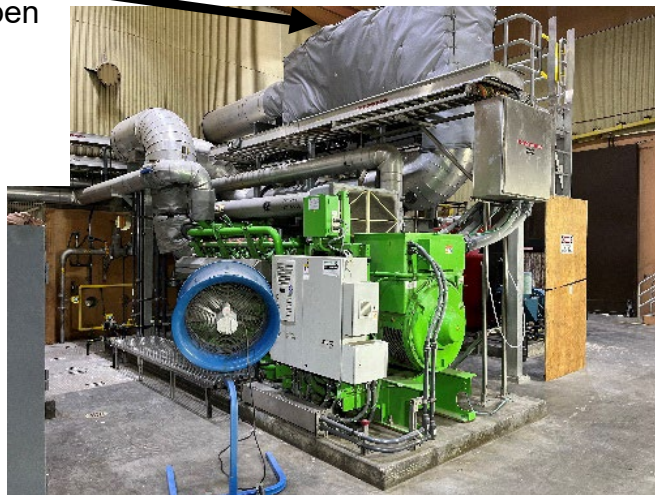
The SCR system was found to be too hot when operating. The final and successful solution was to remove sections of the insulating heat recovery water jacket. Unfortunately, this exposed metal is around 800 Fahrenheit and unsafe for employees maintaining the Cogen SCR. The removal of a portion of the heat recovery system also impacts the ability to recover sufficient heat on the coldest days of the year. This has led to the need to operate the supplemental boiler.

Top of SCR has no blanket and is open to atmosphere.

RTP Cogen SCR Ladder Out of Service Covered by Plywood

This agenda item provides a recommendation for the PC 17 Engineering Committee Members to recommend to the PC 17 Board to award the installation of the Stueler blower modification on the RTP Cogen selective catalytic reducer (SCR). Western Energy is the authorized representative for Stueler, the manufacturer of the SCR, in California. The quote from Western is \$45,450.23 plus tax, shipping, and fees to be determined at the time of shipping. Staff is requesting a \$5,000 contingency to cover unforeseen construction and installation conditions, such as the issues with the condition of the metal inside of the SCR housing system when it is cut open. The total costs will exceed \$50,000.
