# Hydroseed Restoration

## DUDEK SITE OBSERVATION REPORT

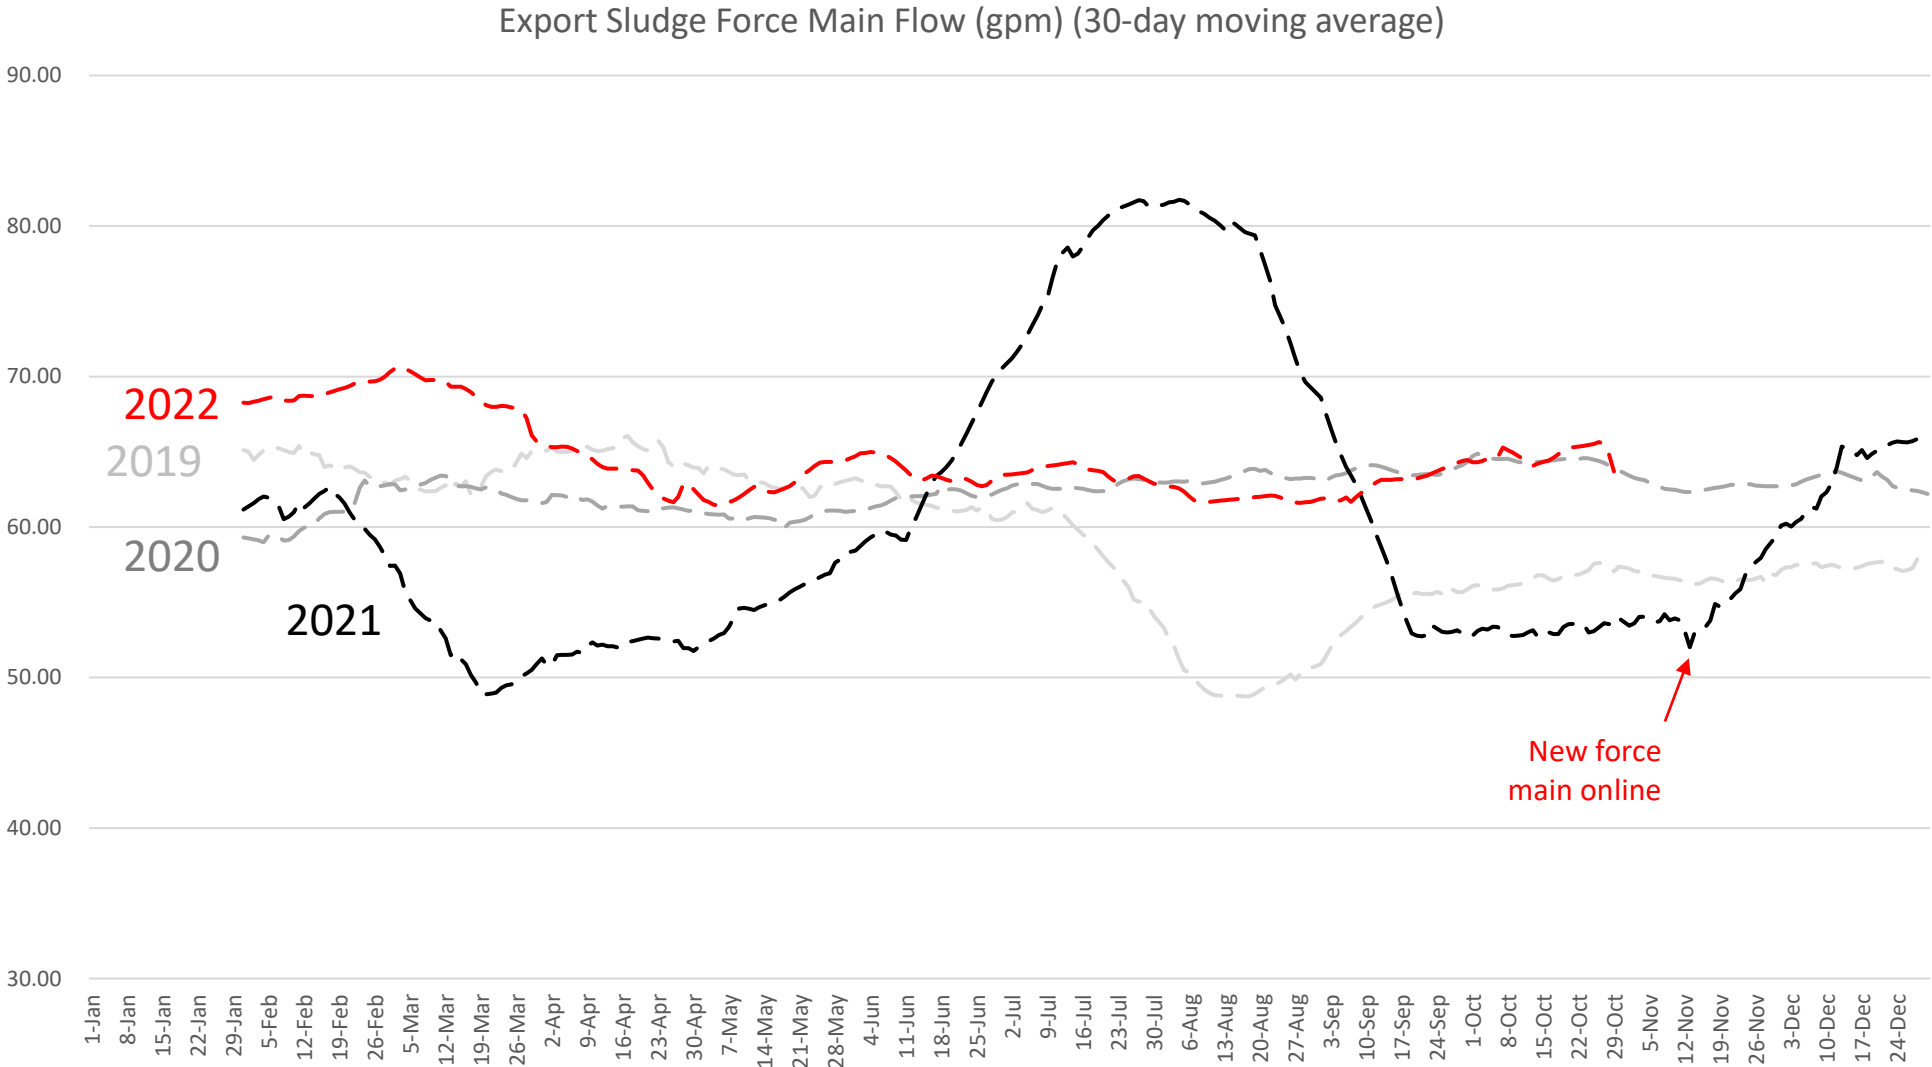
# Sludge Flow Over Time

Annual average flow is slightly higher in 2022 (64 gpm vs. <62)

Flow rate is extremely steady compared to previous years

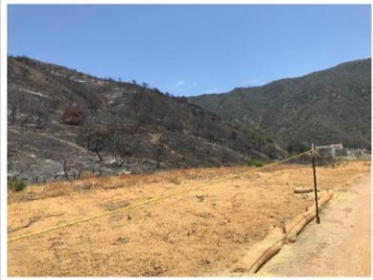
Fire burned to the edge of the site. It appears the site itself may have acted as a fire break (6/23/22).

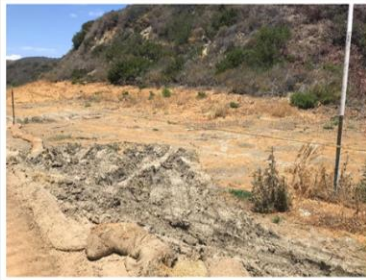
Soil disturbance within site from fire fighting efforts in the area (6/23/22).

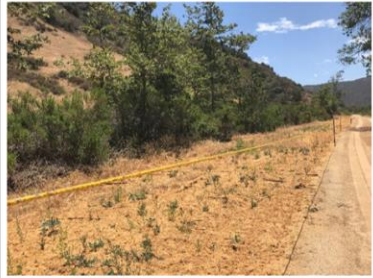
Patch of non-native weeds west of bee hives (6/23/22).

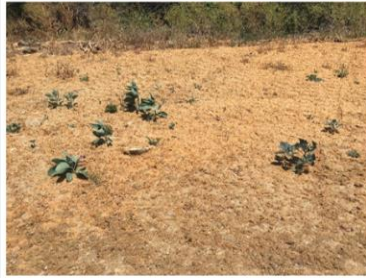
Non-native tree tobacco seedlings germinated in a small patch within the site (6/23/22).
