External Inspection and Condition Assessment Survey

Client: South Orange County Wastewater Authority
Date: January 24, 2023
Attn: Amber Baylor
Director of Environmental Compliance
Subject: Ocean Outfall External Inspection and Condition Survey of the ACOO

Client: South Orange County Wastewater Authority
Date: January 24, 2023
Attn: Amber Baylor
Director of Environmental Compliance
Subject: Ocean Outfall External Inspection and Condition Survey of the SJCOO

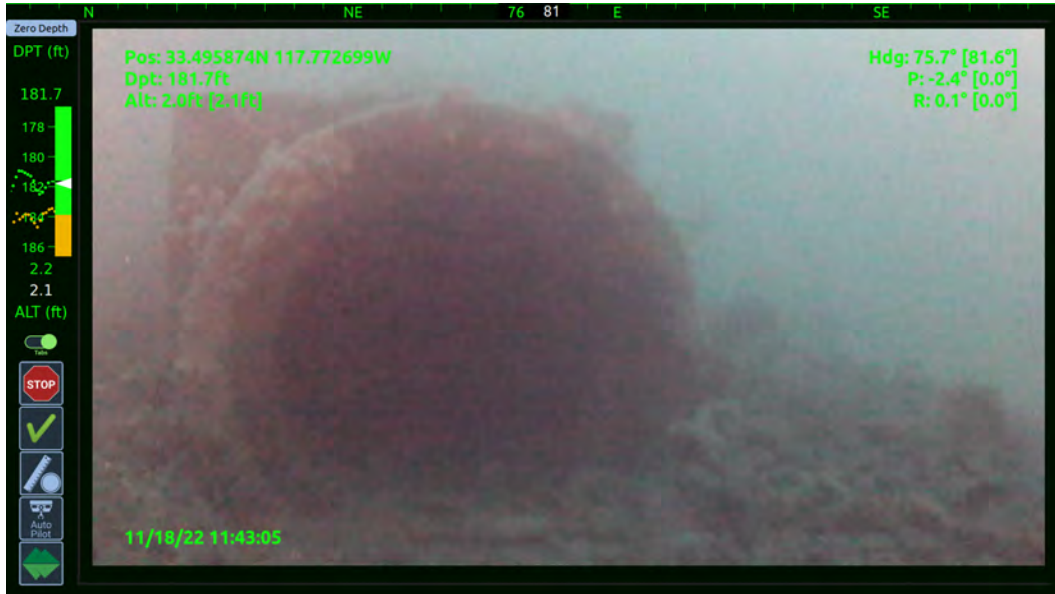
Photo 1 – View at the ACOO end structure

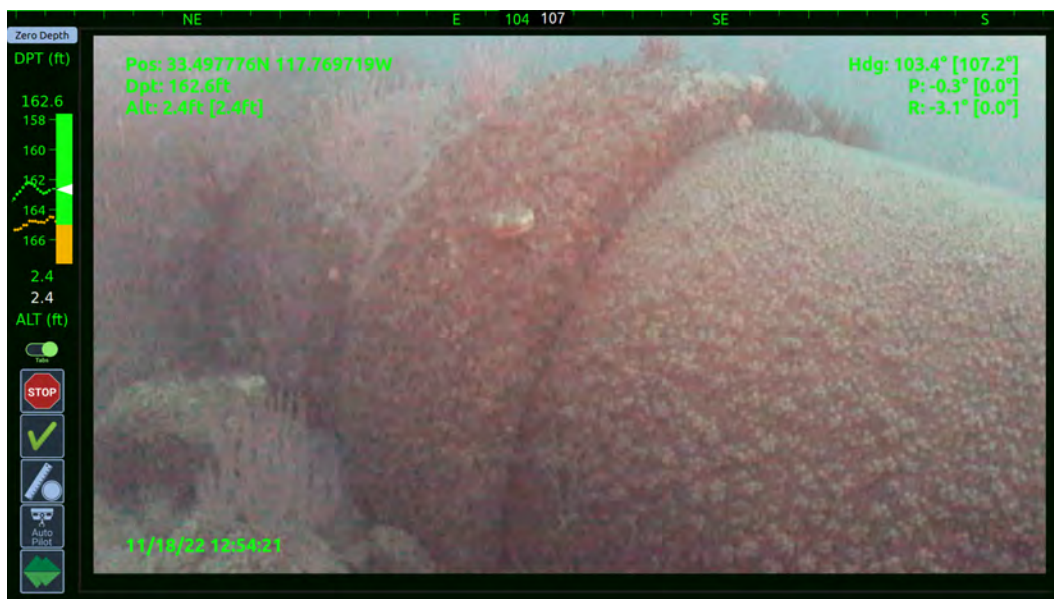
Photo 4 – View showing the typical condition of a bell joint at the ACOO

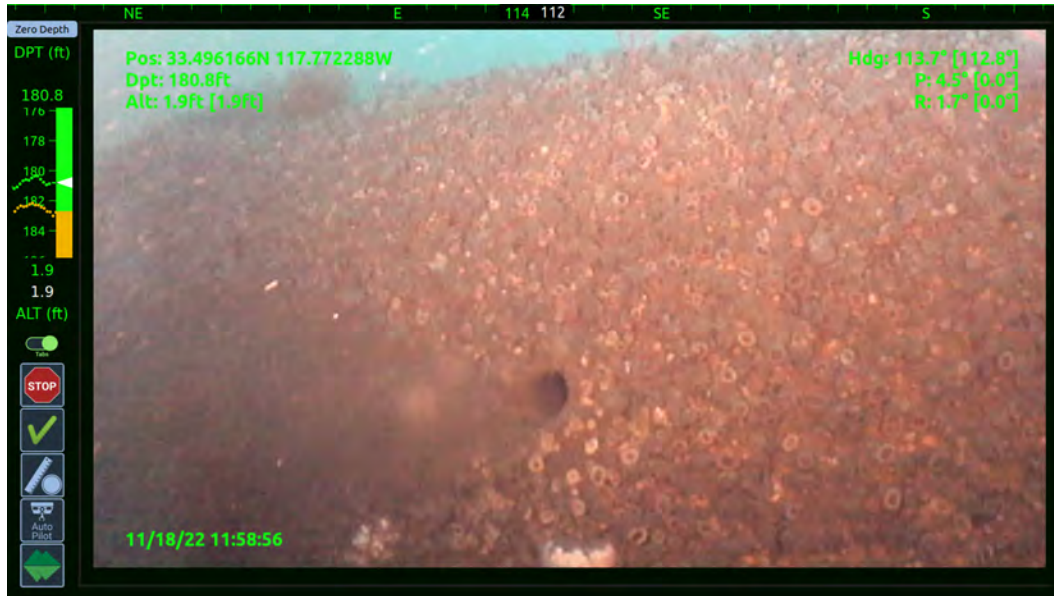
Photo 5 – View of one of the ACOO diffuser ports, with effluent flowing

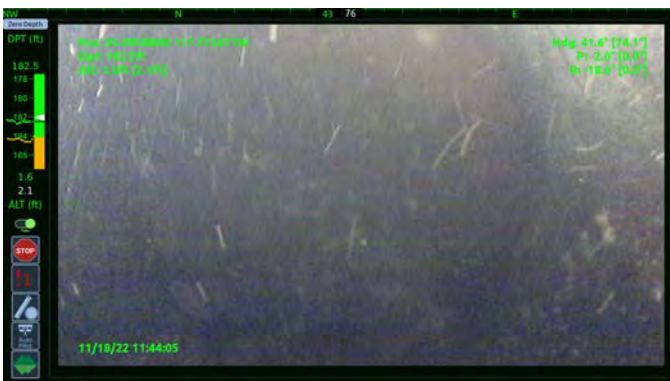
Entry 6 Gate Closed

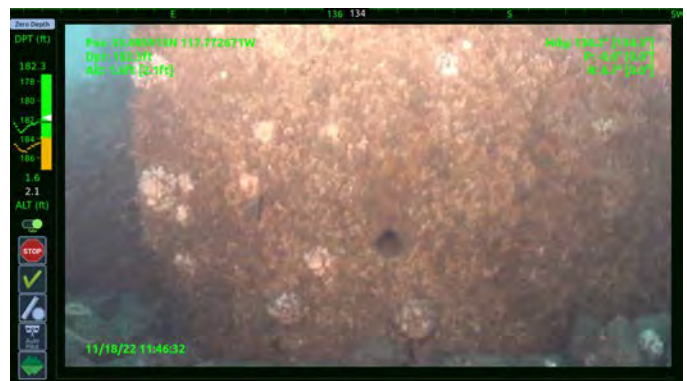
Entry 7 North diffuser not flowing

1. In areas along the length of the ACOO where ballast is absent, install ballast such that the original design cross sectional is restored. The previous ballast repair efforts were observed to be in good condition. Utilizing the same means and methods would be a reasonable course of action to address the areas of missing ballast.
2. Using mechanical means and methods, clean each of the ACOO diffuser ports of marine growth and remove any obstructions.

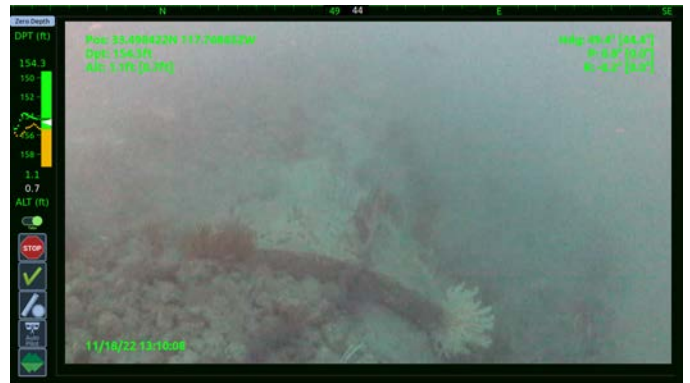
Entry 161 In and out of sand

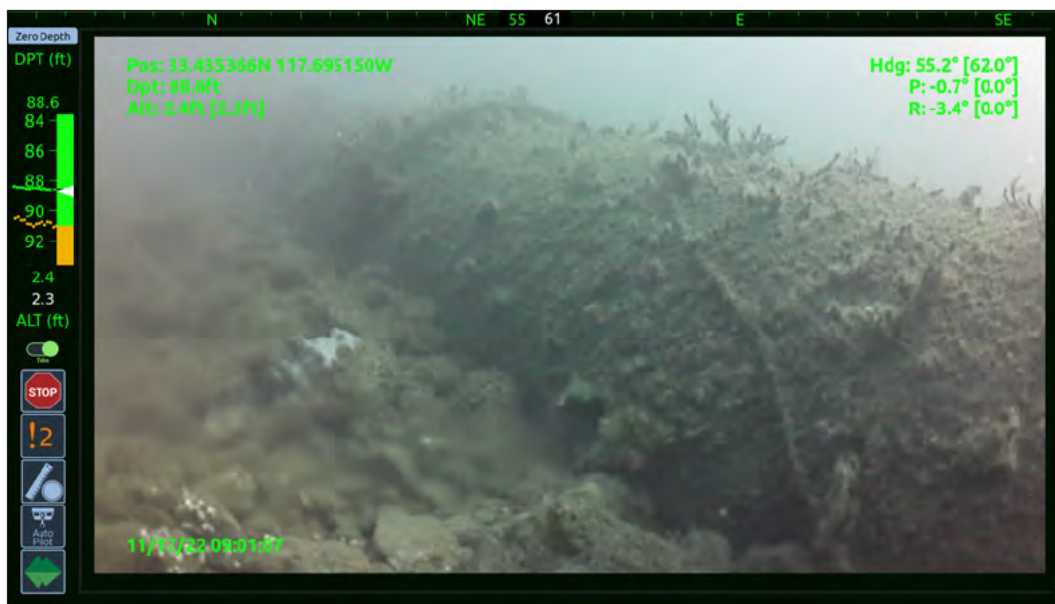
Photo 6 – View of an additional SJCOO diffuser port, with effluent flowing

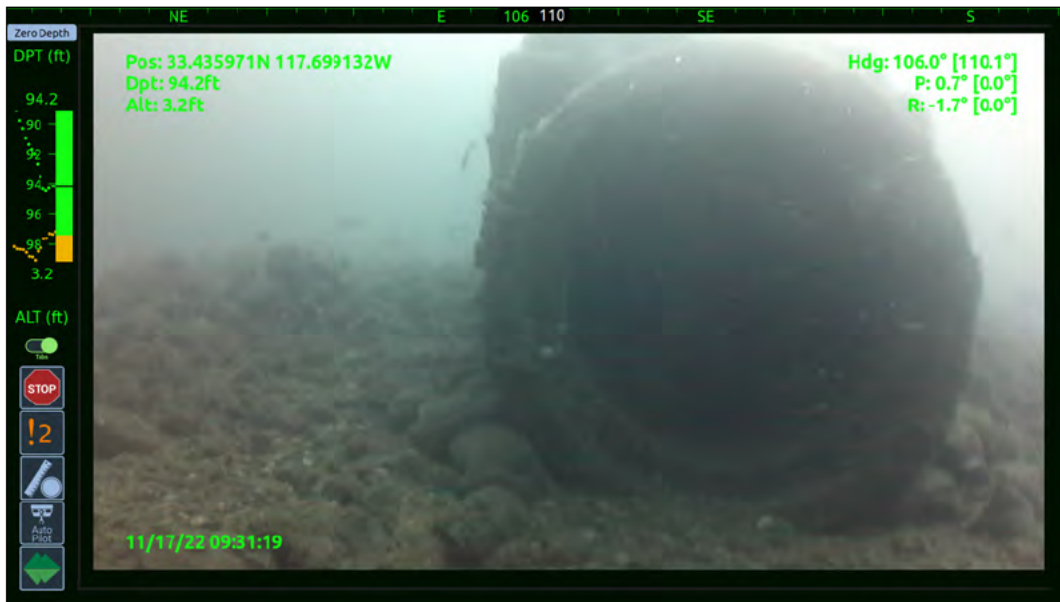
Photo 10 – View of the SJCOO end structure

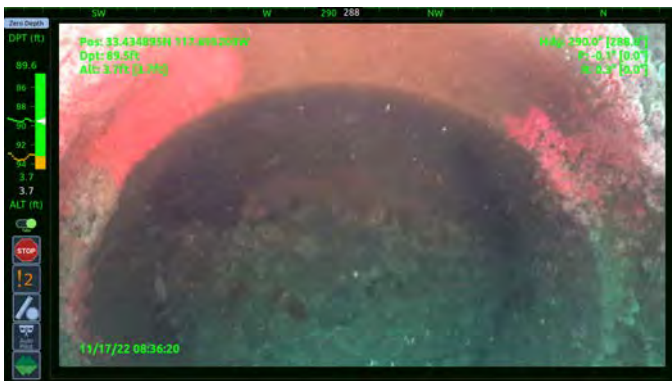
Entry 9 - Junction Box South Gate Closed
