External Inspection and Condition Assessment Survey

Client: South Orange County Wastewater Authority
Date: January 24, 2023
Attn: Amber Baylor
Director of Environmental Compliance
Subject: Ocean Outfall External Inspection and Condition Survey of the ACOO

Client: South Orange County Wastewater Authority
Date: January 24, 2023
Attn: Amber Baylor
Director of Environmental Compliance
Subject: Ocean Outfall External Inspection and Condition Survey of the SJCOO

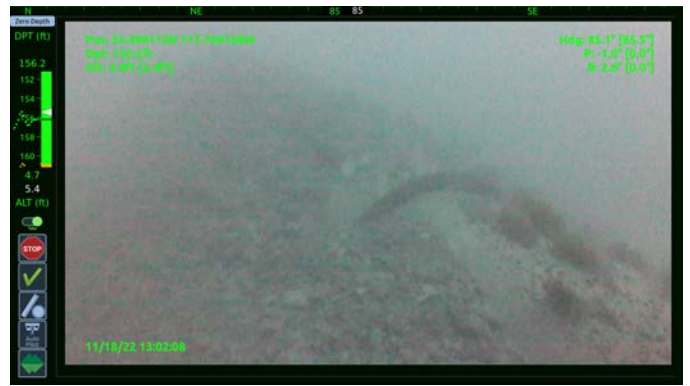
Entry 155 Getting buried

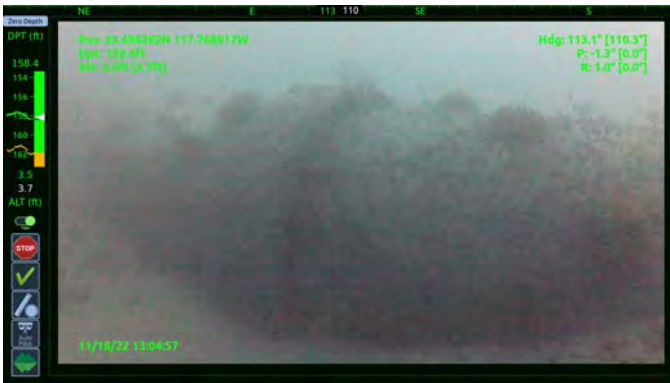
Entry 157 Getting more buried

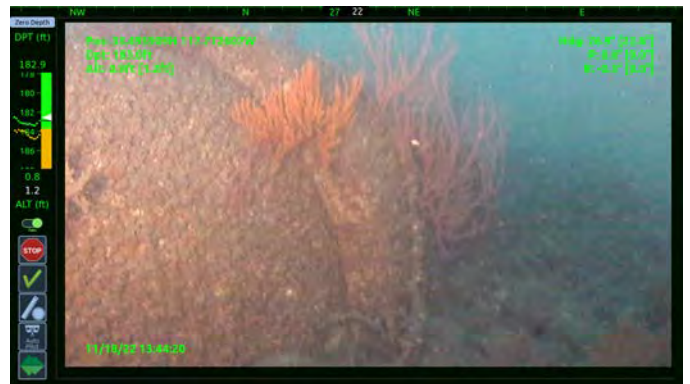
Entry 170 D4 Starting on southeast side

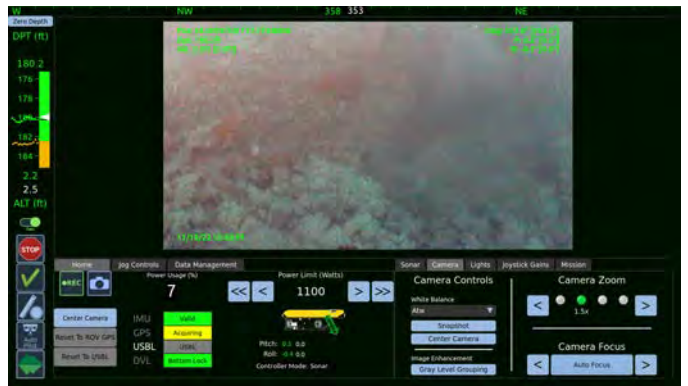
Entry174 Flange 2 buried

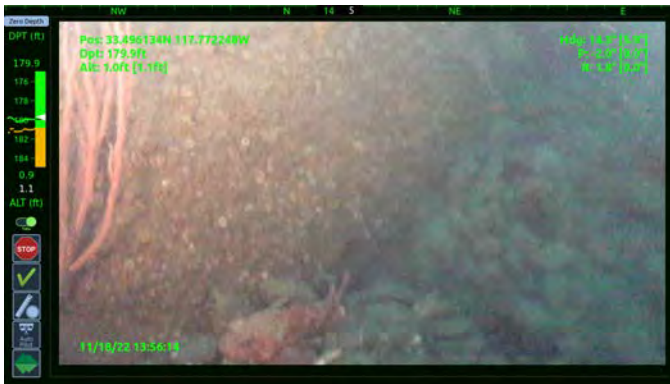
Entry 186 D26 Buried

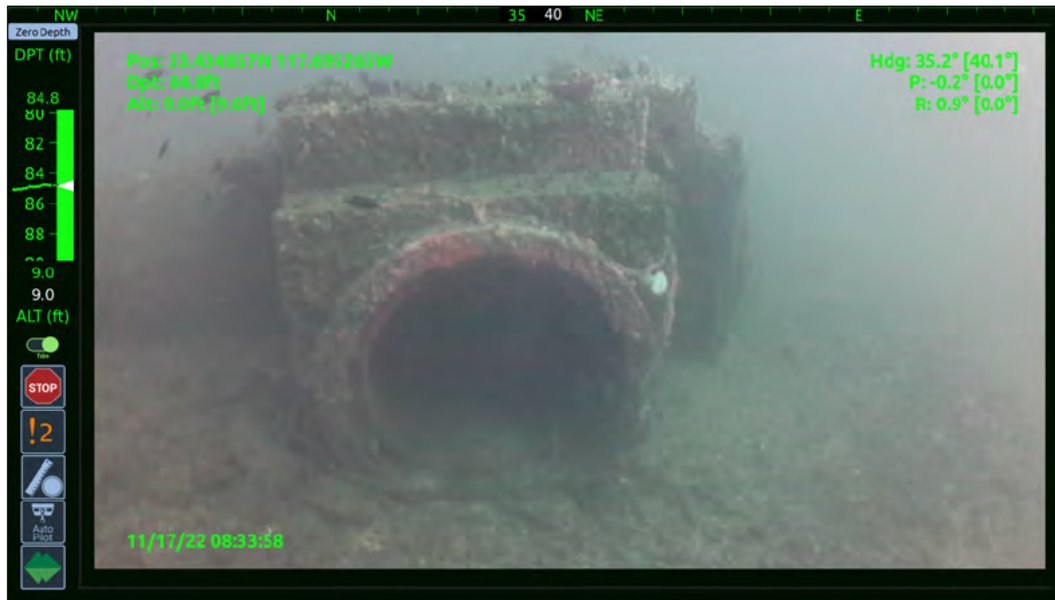
Photo 1 – View at the SJCOO junction

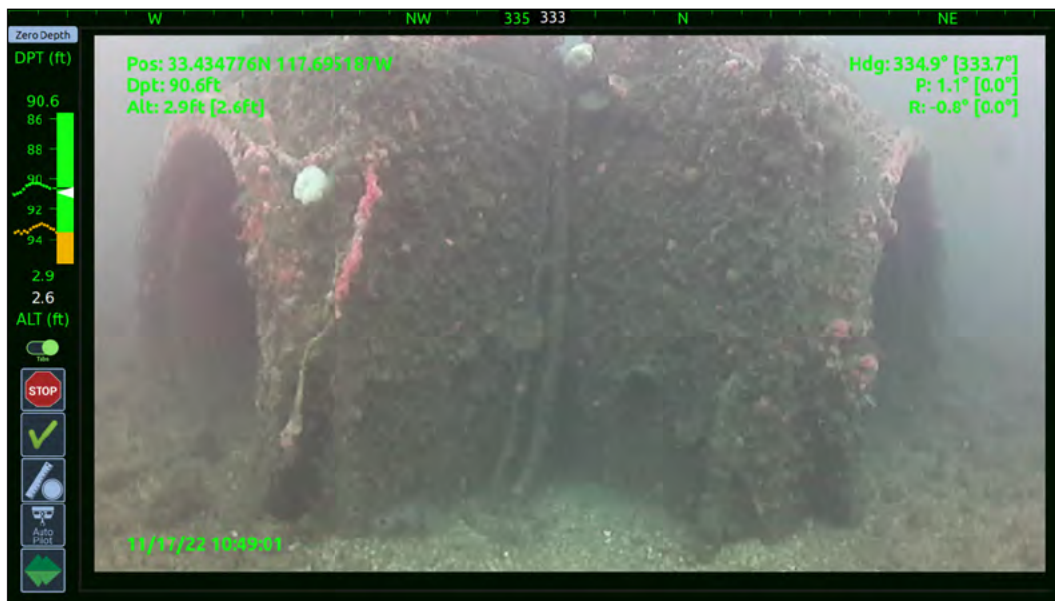
Photo 2 – View at the SJCOO junction

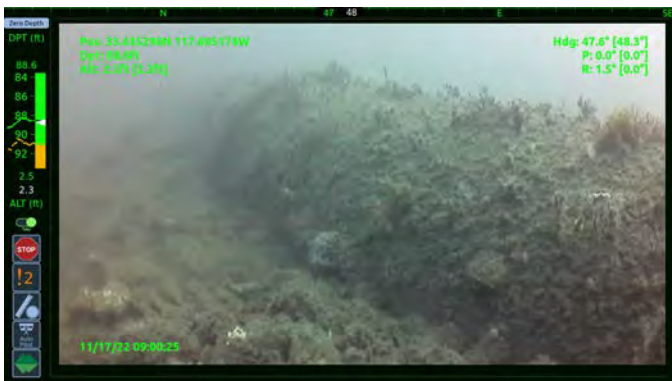
Entry 48 - D9

46	11/17/22 8:57	SS MB 7 flowing but can't see Diffuser, buried to spring line
47	11/17/22 8:58	SS flange 4
48	11/17/22 8:59	SS MB 9, exposed and flowing - Ballast is missing at this location (+/-10 ft)
49	11/17/22 8:59	SS flange 5
50	11/17/22 9:00	SS MB 11 flowing but in rock
51	11/17/22 9:00	SS flange 6
52	11/17/22 9:01	SS MB 13 flowing but covered in rock
53	11/17/22 9:01	SS flange 7

1. In areas along the length of the SJCOO where ballast is absent, install ballast such that the original design cross sectional is restored. The previous ballast repair efforts remain intact. Utilizing the same means and methods would be a reasonable course of action to address the areas of missing ballast.
